NATIONAL PROGRAM FOR INSPECTION OF NON-FEDERAL DAMS
RUSSELL MILL POND (MA.) (U) CORPS OF ENGINEERS WALTHAM
MA NEW ENGLAND DIV MAR 80

MERRIMACK RIVER BASIN
CHELMSFORD, MASSACHUSETTS

RUSSELL MILL POND
MA 01219

PHASE I INSPECTION REPORT
NATIONAL DAM INSPECTION PROGRAM

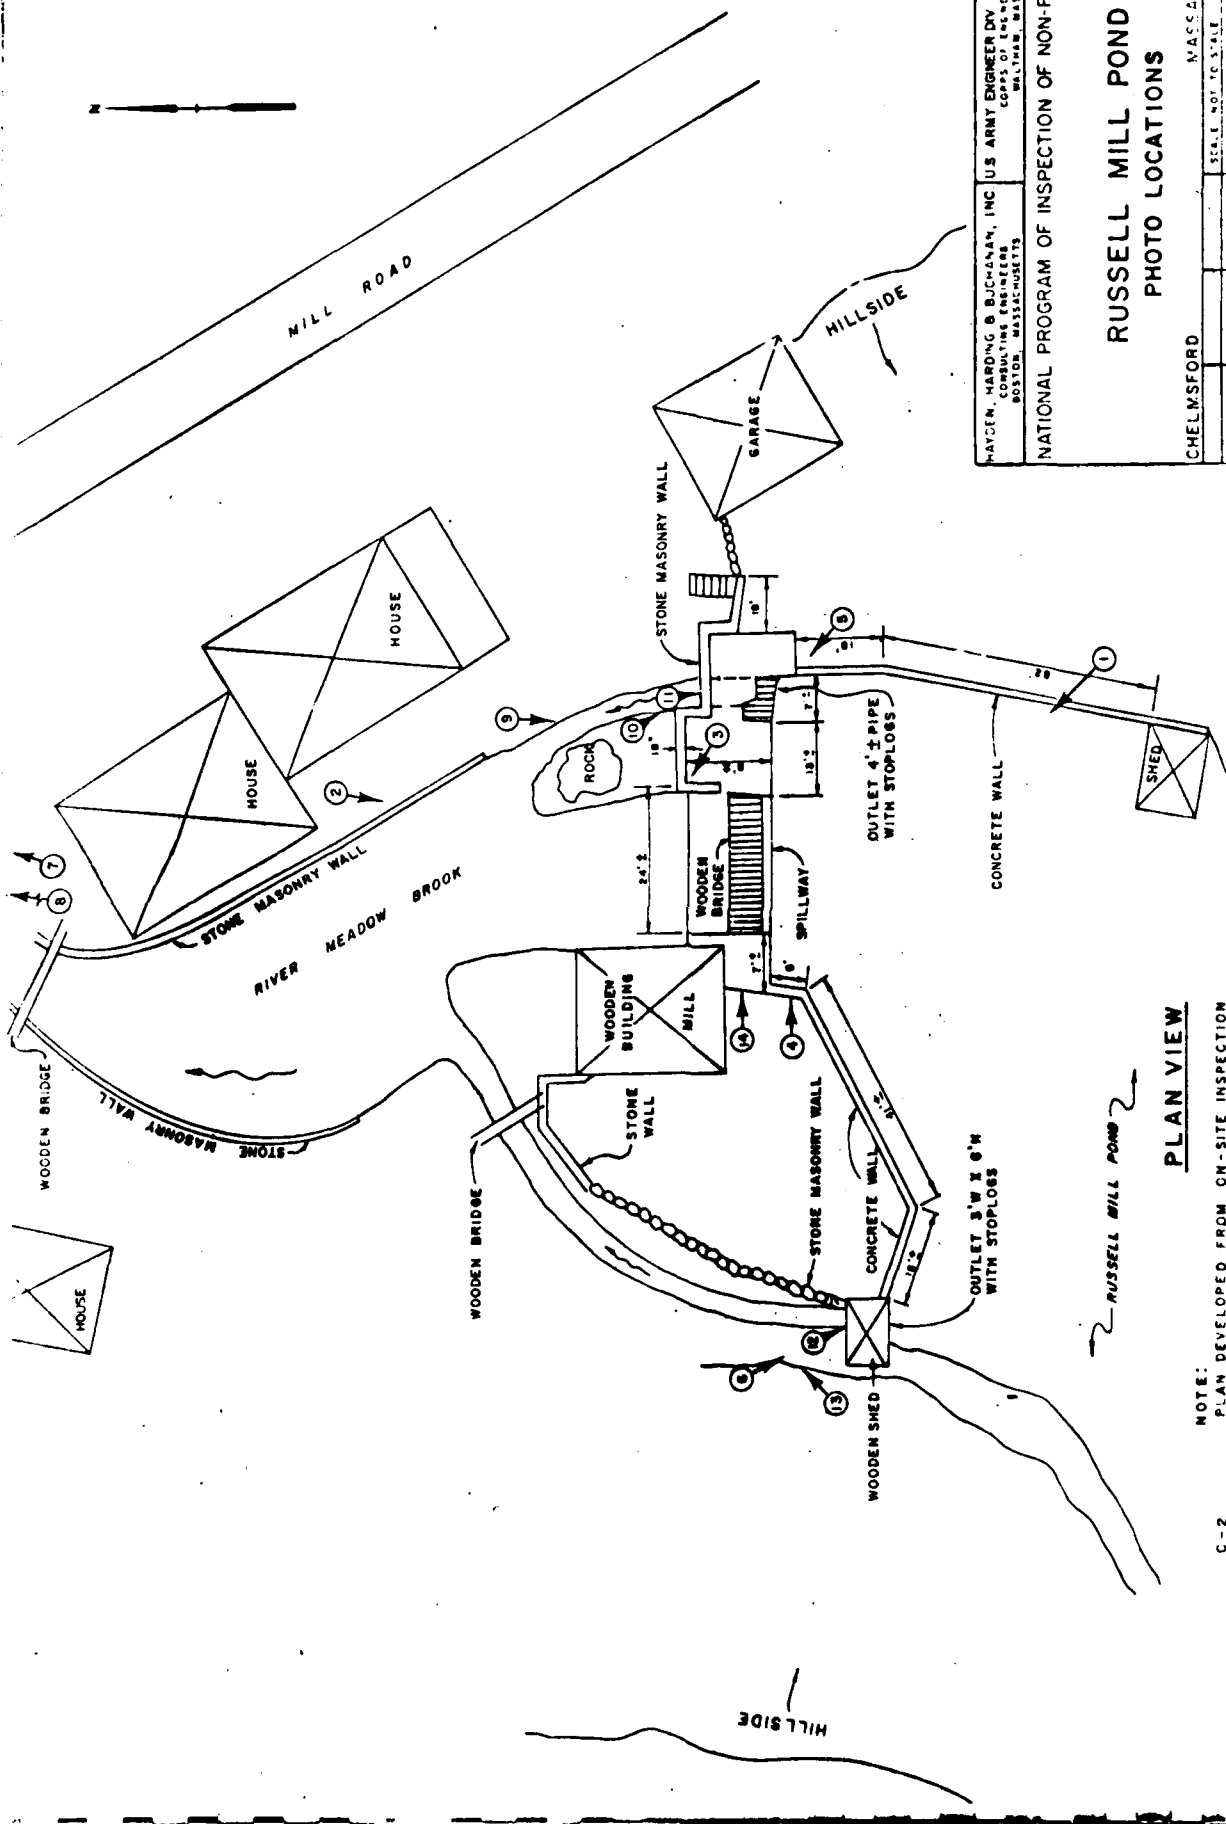
PHOTO NO. 1 - View of upstream face of Dam. Shown are the spillway, the 3 x 6 foot sluiceway below the small wood shed at the far left of the spillway, and the 4 foot pipe sluiceway to the right of the spillway, below the wood deck area. Beyond the spillway is the outlet channel area of Photo No. 3.
